# SERVICE BULLETIN

KALLITHEA

Replacement of the Turbocharger–  
Intercooler Flexible Hose and Updated  
Installation Procedure

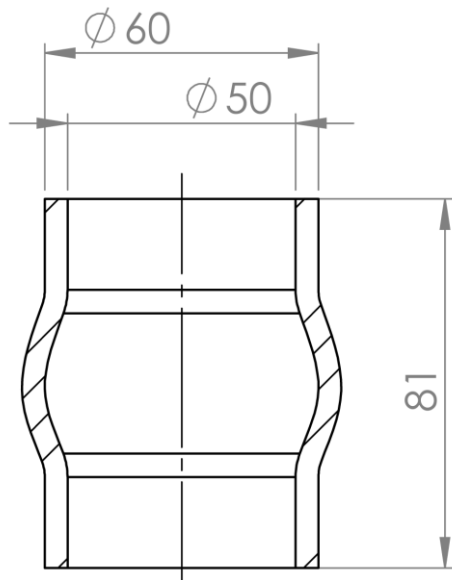
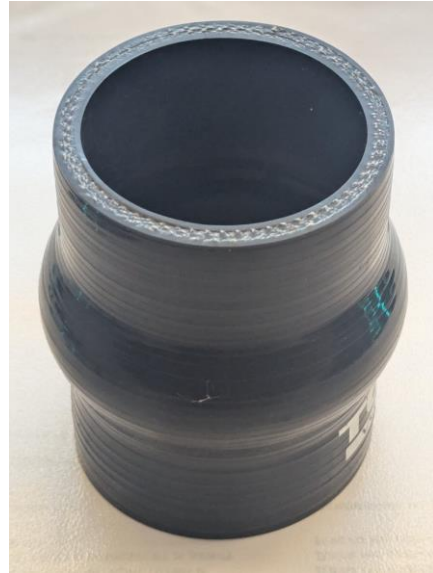
Fig. 1

- flexible silicone coupling with one hump x1 (Fig. 1)
- hose clamp (ABA Original S20 Aluzink x2 (Fig. 2)

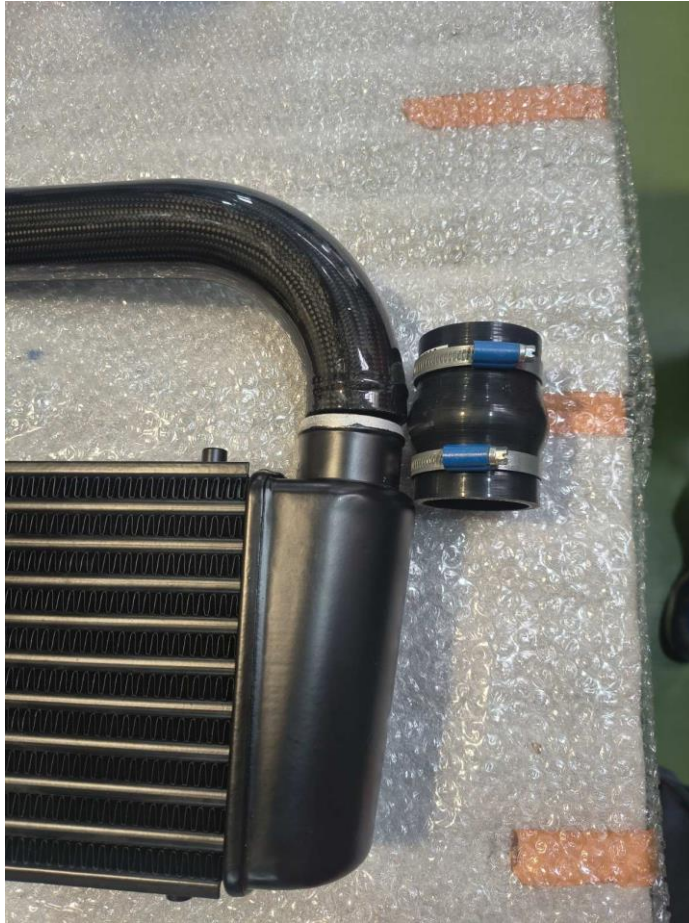
- Fig. 3 – Updated hose configuration
- Fig. 4 – Correct clamp position
- Fig. 5 – Incorrect clamp position

- 1) Install the updated flexible hose.
- 2) Install new hose clamps.
- 3) Ensure the hose is fully seated on both connections.
- 4) Position the hose clamps aft of the hump on the carbon fiber pipe
- 5) Tighten clamps to the specified torque.
